ITEK LABORATORIES
10 Maguire Road
Lexington 73, Massachusetts

Processor Progress Report from 1 February to 1 March 1963

Processor Progress Report from 1 March to 1 April 1963

Processor Progress Report from 1 April to 1 May 1963

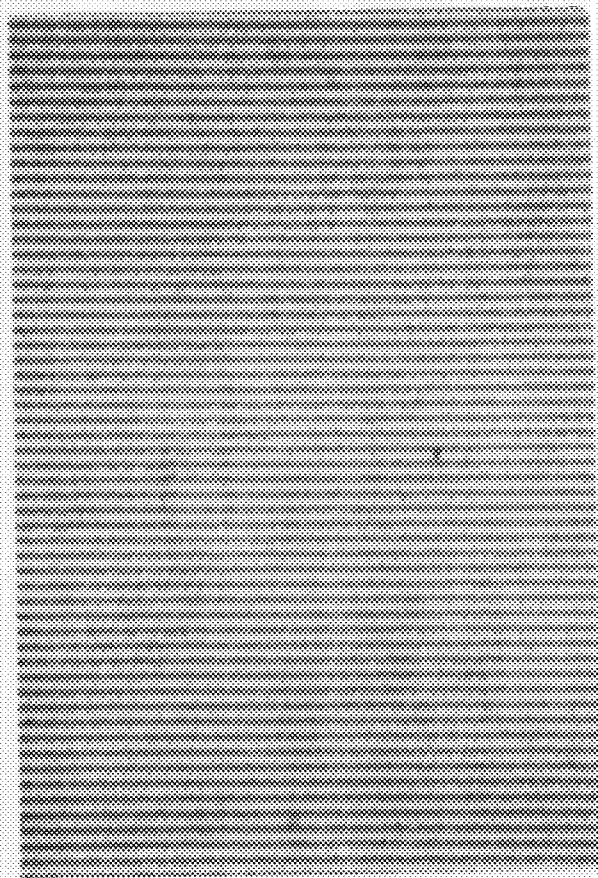
Image Obtained in Range Resolution Test

Range Resolution: New long line resolution targets of 24, 32, 40, 66, 88, 110 lines per millimeter were made up. These were used in conjunction with the camera and best resolution obtained was 88 lines per millimeter at the input. Since in the application only 40 lines per millimeter will be used most of the work done was to increase the contrast at this level. Figure 1 is a 40X enlargement of the results. The first run on the roller platen was overexposed and will be rerun during the early part of March. Table I outlines the tests made.

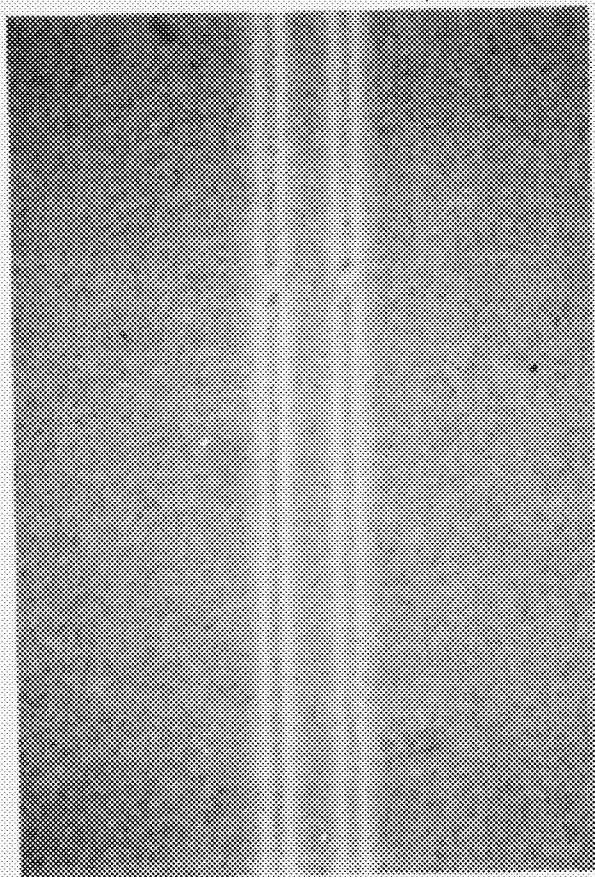
Image Obtained in Azimuth Resolution Test

Azimuth Resolution: The camera was also used to obtain the best correlation of the ruled target. A mercury arc source was used to limit the bandwidth. Best preliminary results gave a line width of .002. Figure 2 is a 40X enlargement of this image.

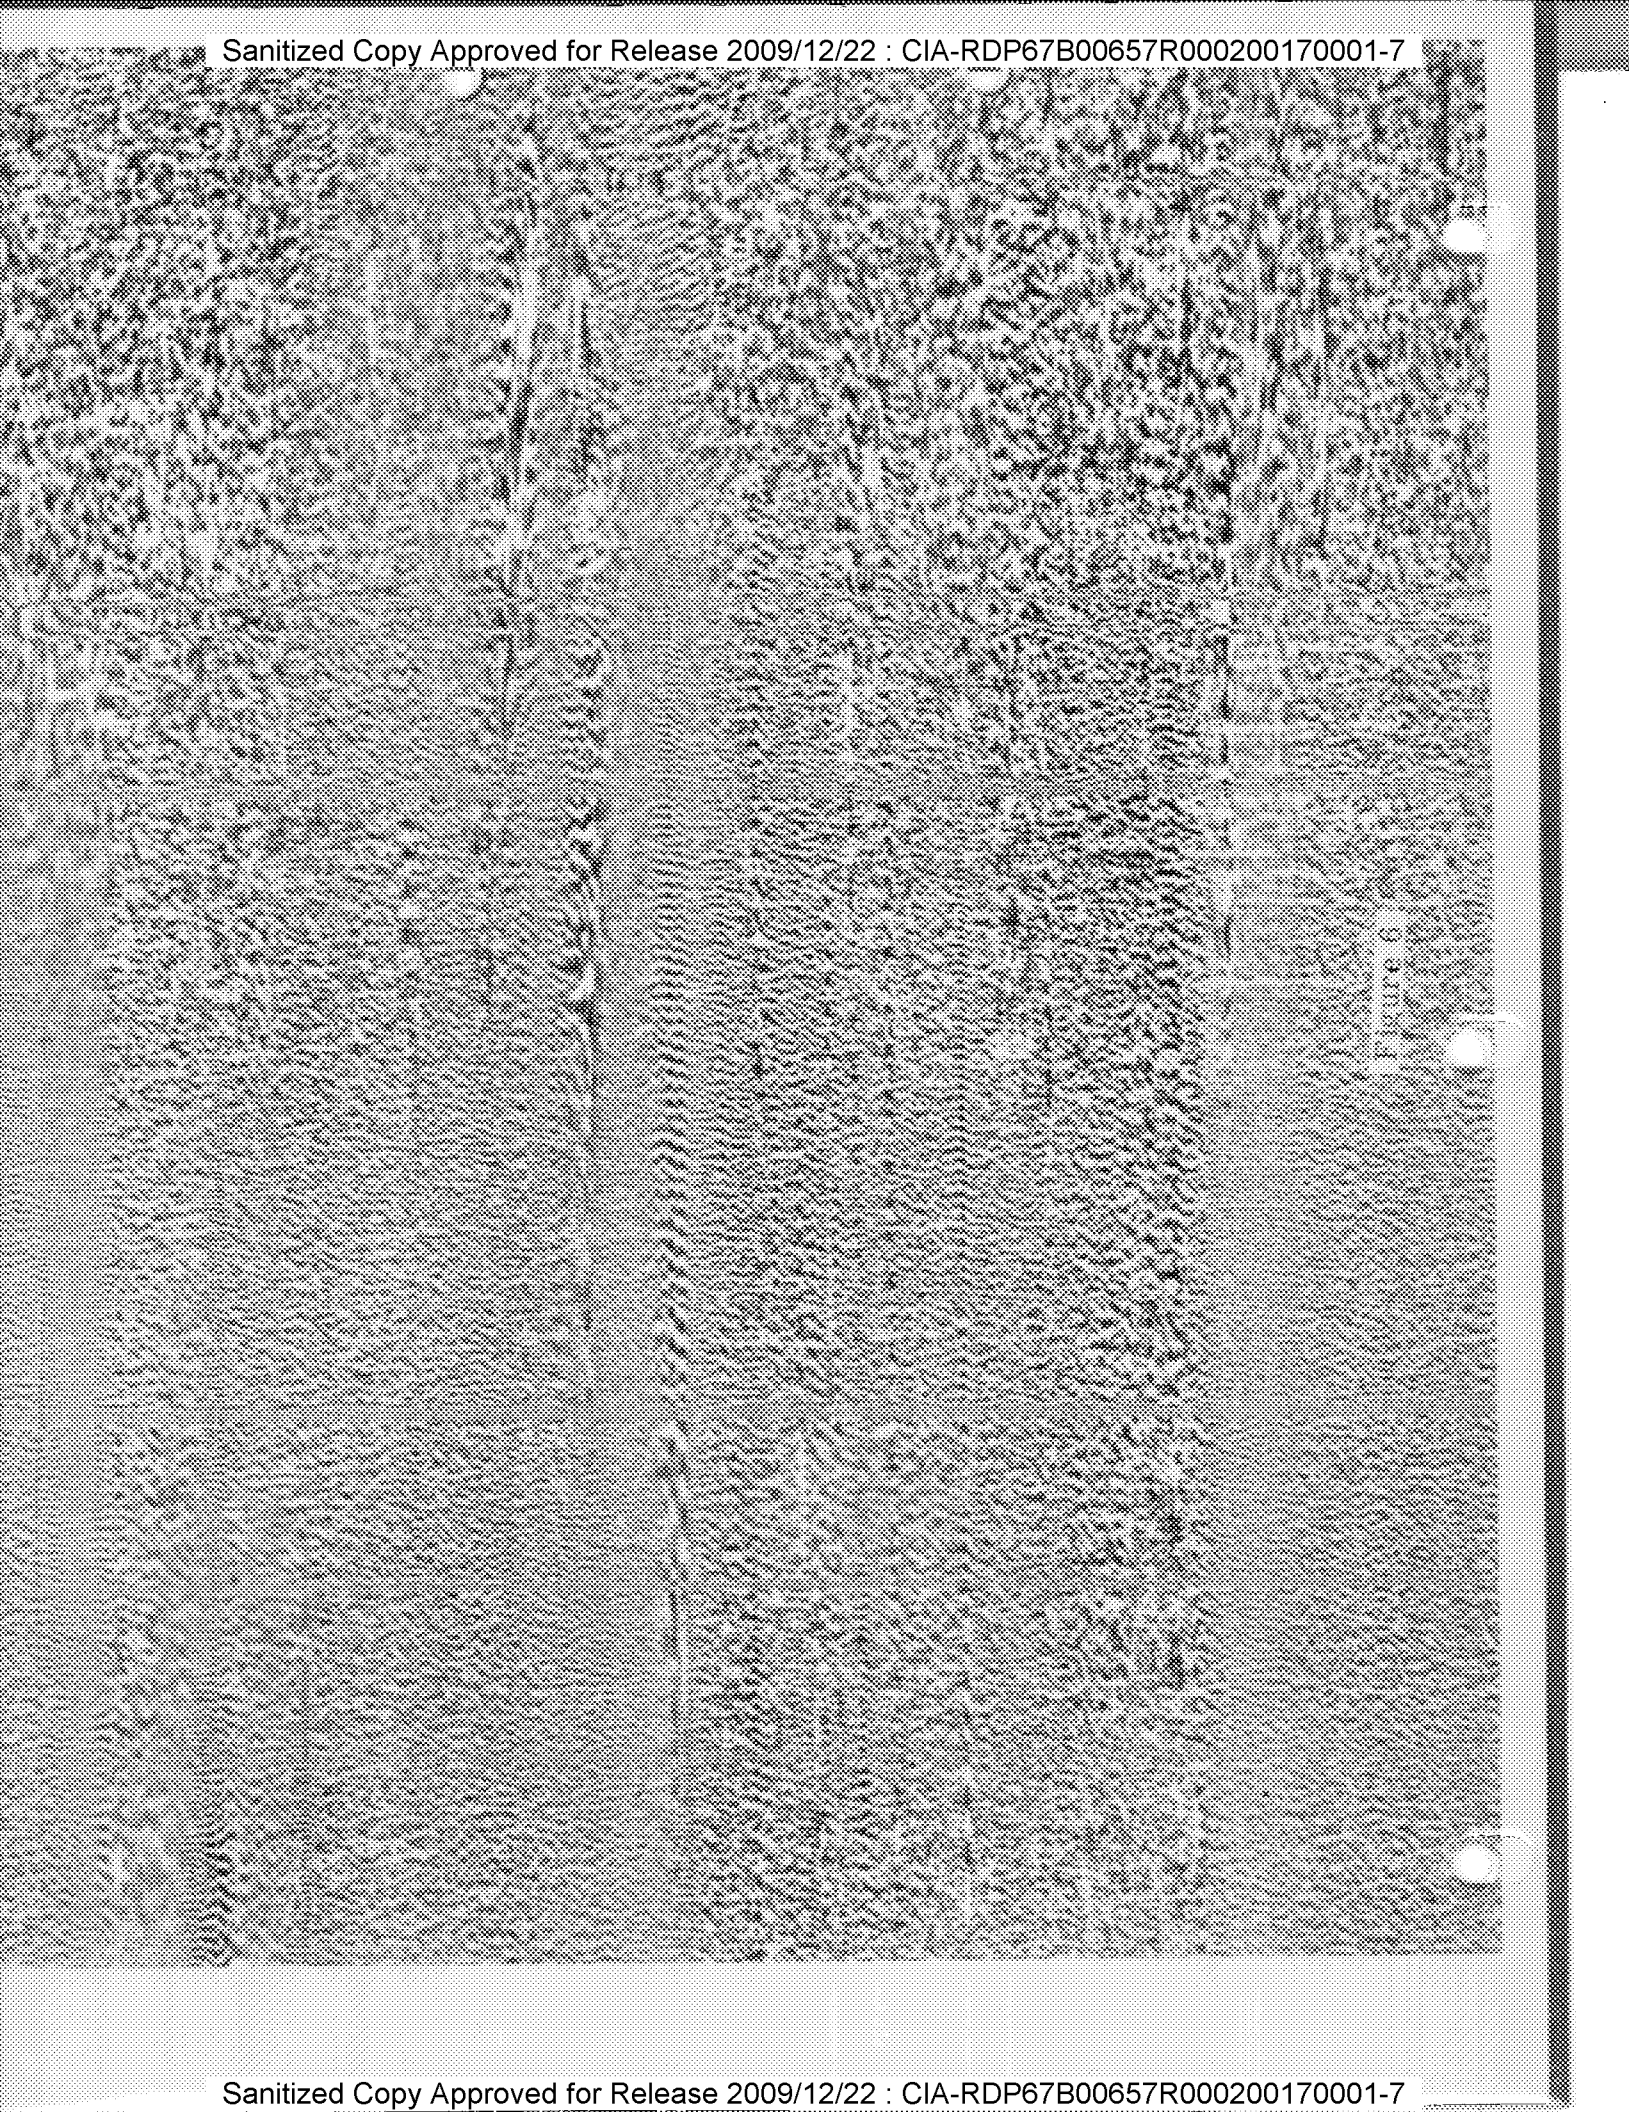
Figure 6 is a 7X enlargement of the primary record showing the stadium and corner reflector area. If the picture is viewed such that the figure number is on the left, the signal history of the reflectors can be seen in the center of the picture, with the zero beats occurring about 1 1/2 inches from the left hand edge of the picture area. The stadium is the U-shaped area above and to the right of the reflectors. It should be noted that the azimuth data is stretched-out approximately 8 3/4 times that in range.

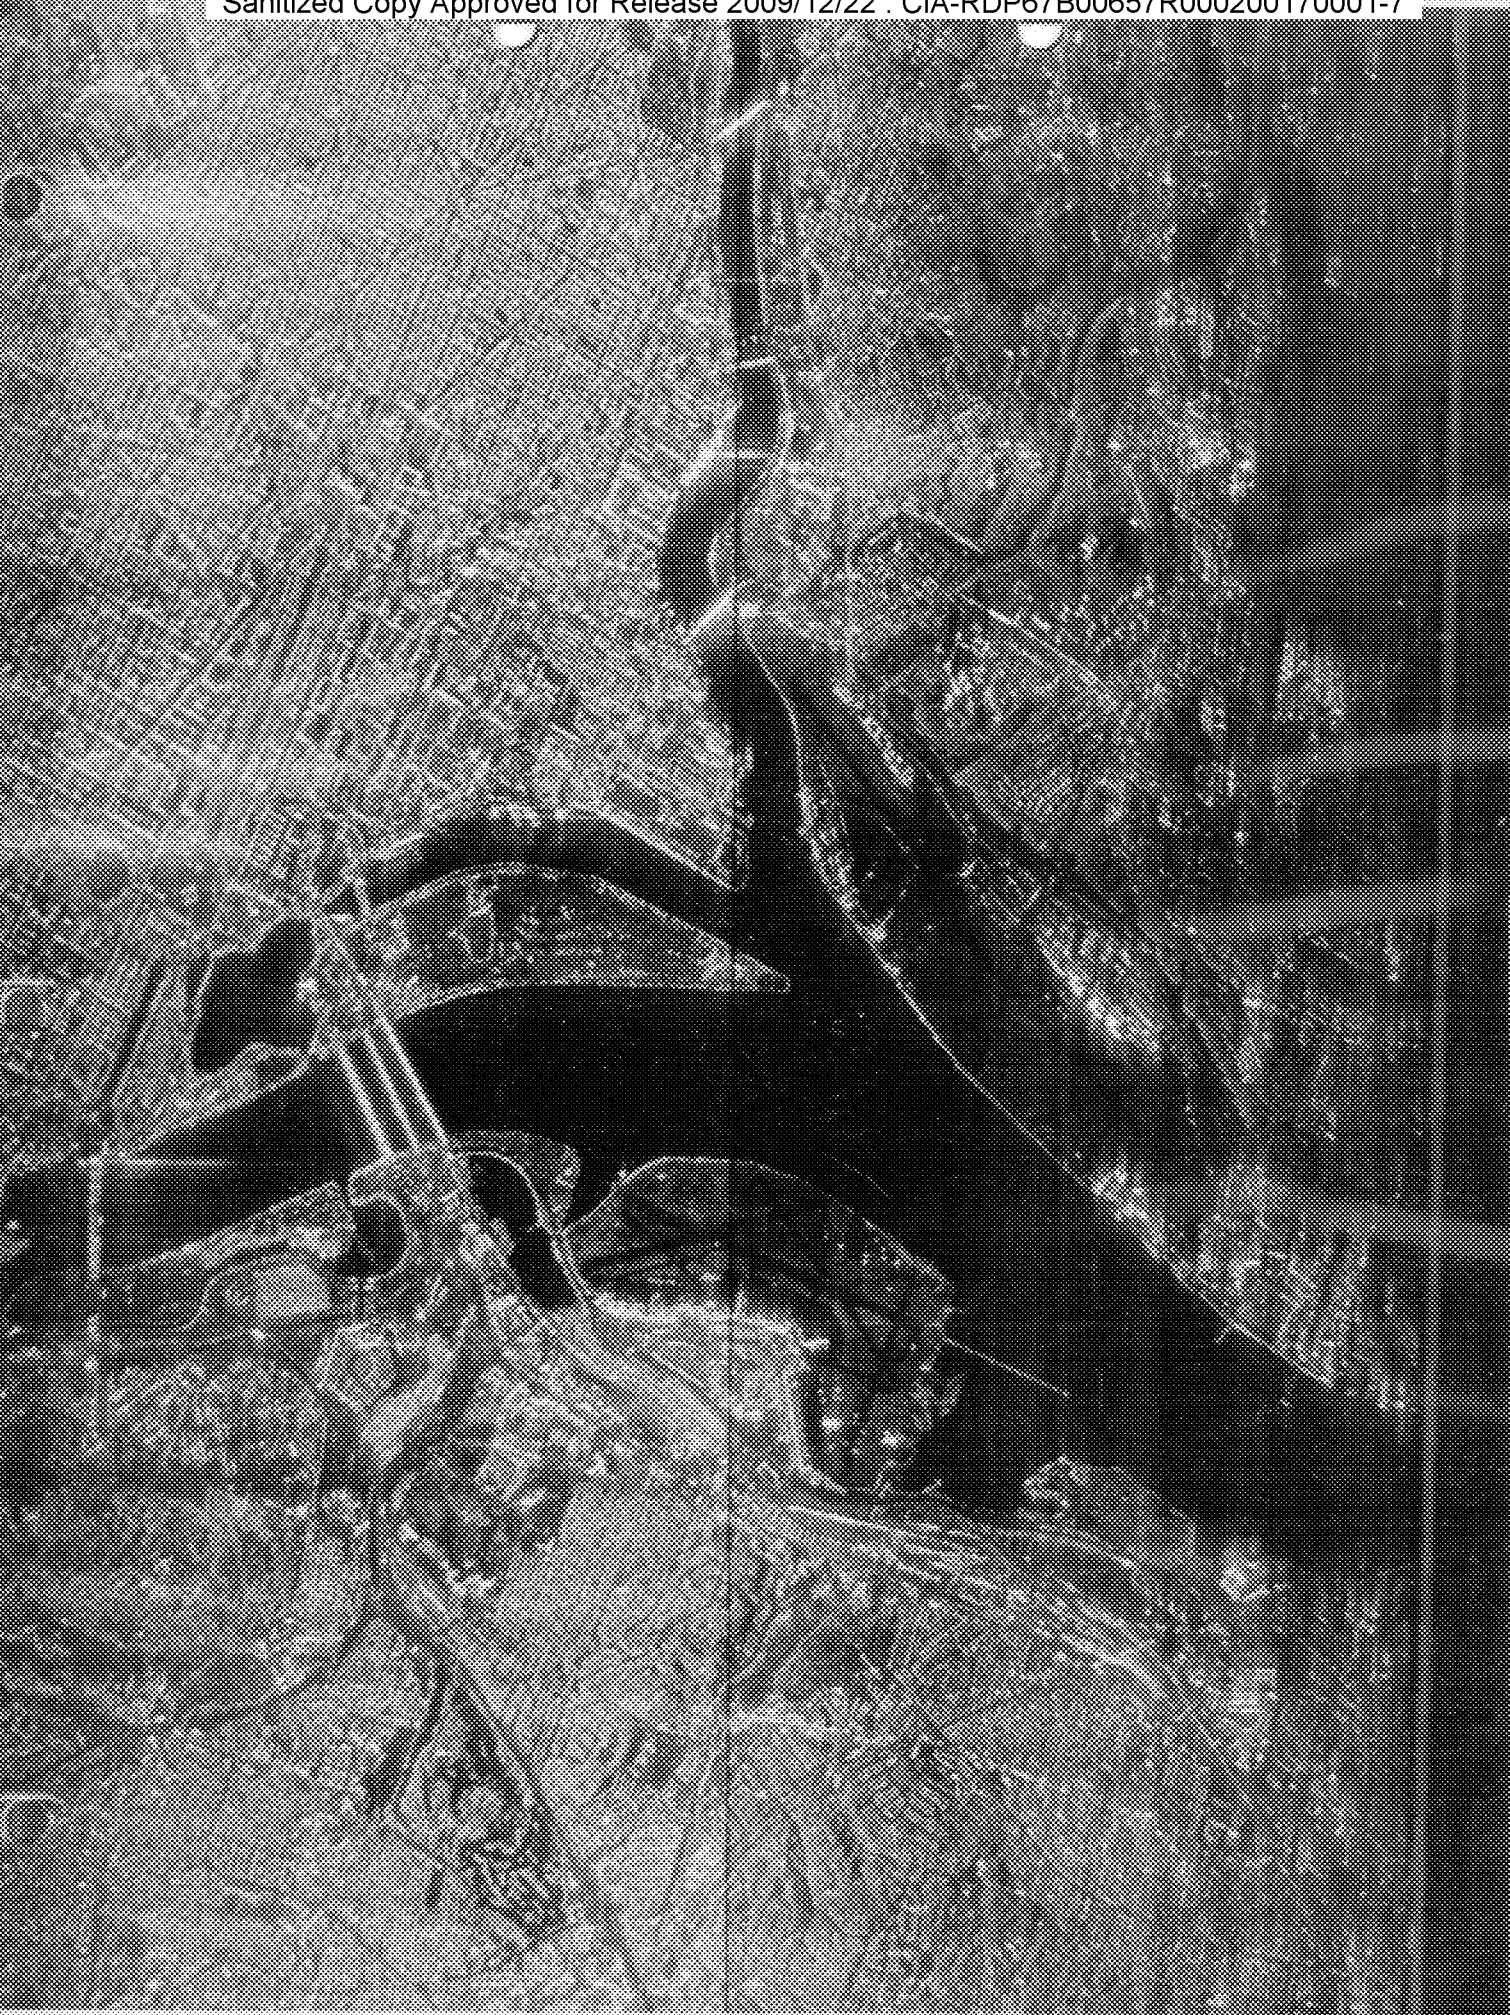
Figure 7

Flight film S-40 was received on 23 February 1963 and correlated. The second run was particularly good (Fig. 7), showing much of the more familiar areas of Washington, D.C. The runway approach lights or supporting structure at National Airport, projecting into the Potomac River are clearly seen, as are airplanes, vehicles or other structures on and around the runways. The detail in this film seemed even better than S-37. Unfortunately, the corner reflectors were not in the mapped area, so no direct comparison between S-40 and S-37 is possible.

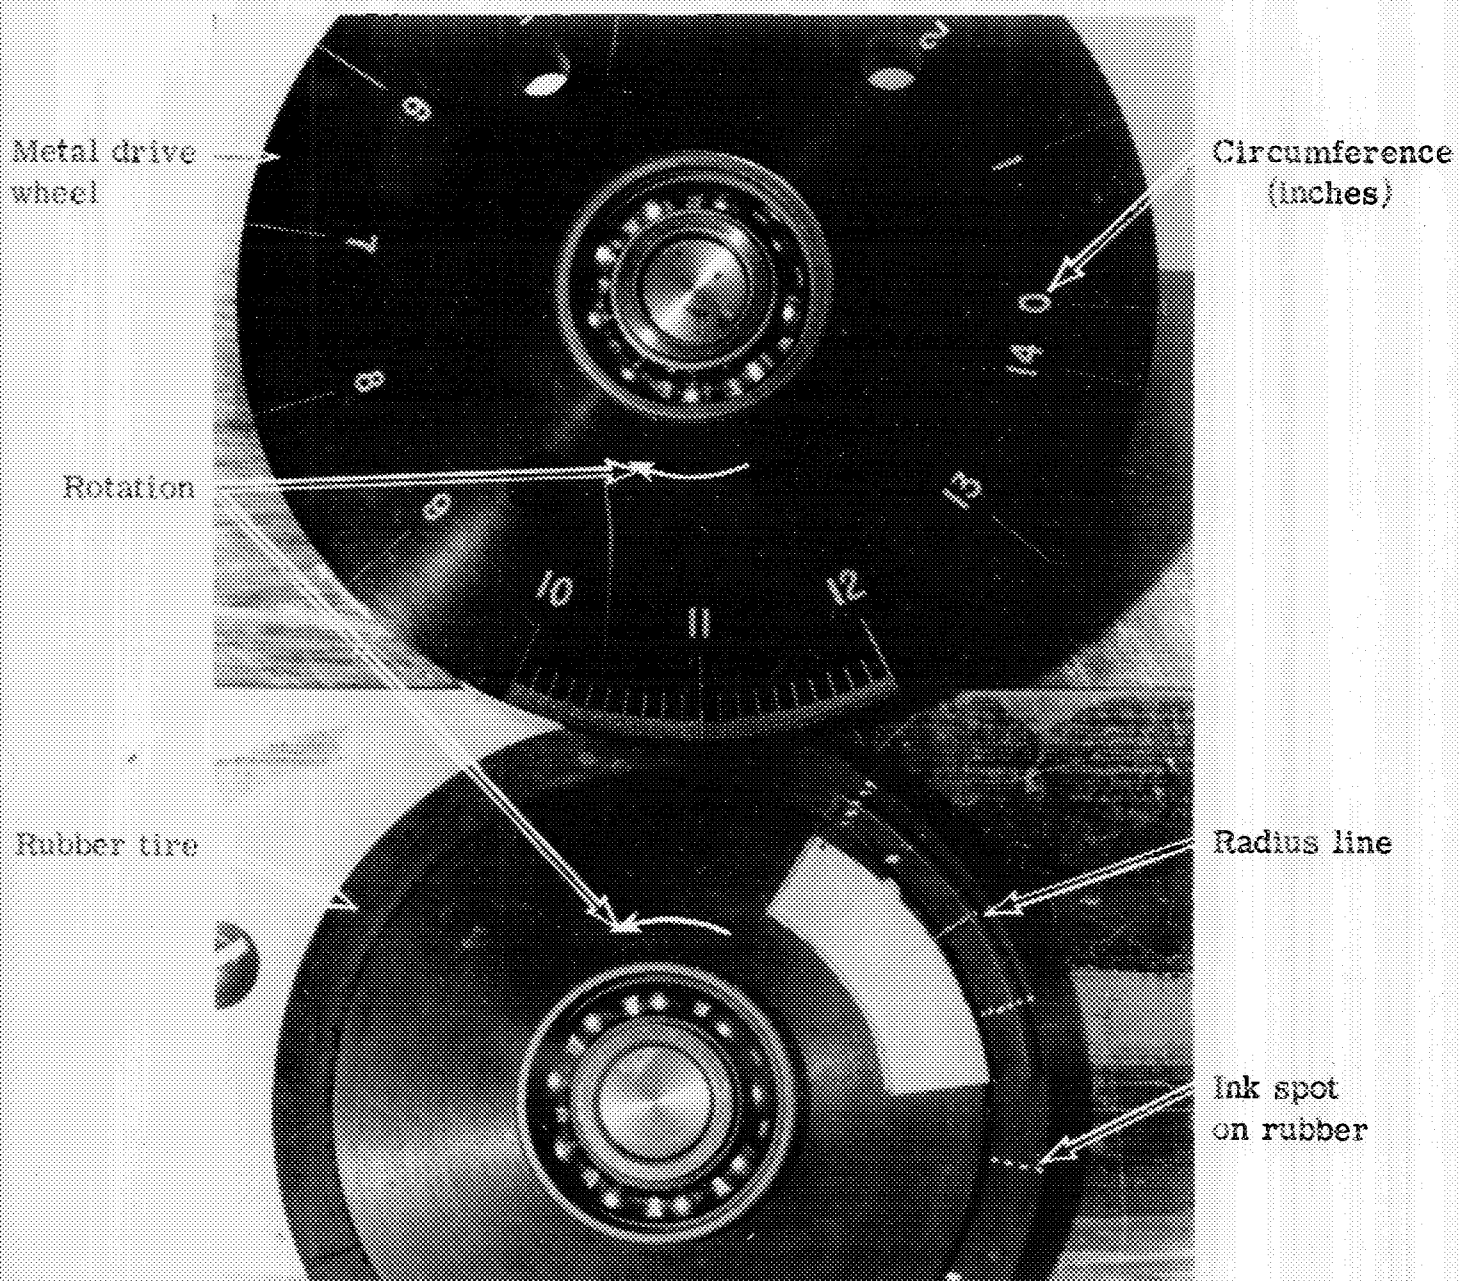
Fig. 1 - Rubber wheel drive test fixture

Drive Study: A test fixture was constructed and used to determine the action of the rubber drive wheels (see Fig. 1). It was found that the drive ratio depends on the depth of insertion in a strange fashion; namely, the speed of the driven rubber wheel decreases as the metal driver wheel is inserted deeper. The action is dependent upon the manner in which the tire deforms, causing the portion of the tire which is in contact to move faster than a radius line on the hub of the wheel as is shown in Fig. 2.

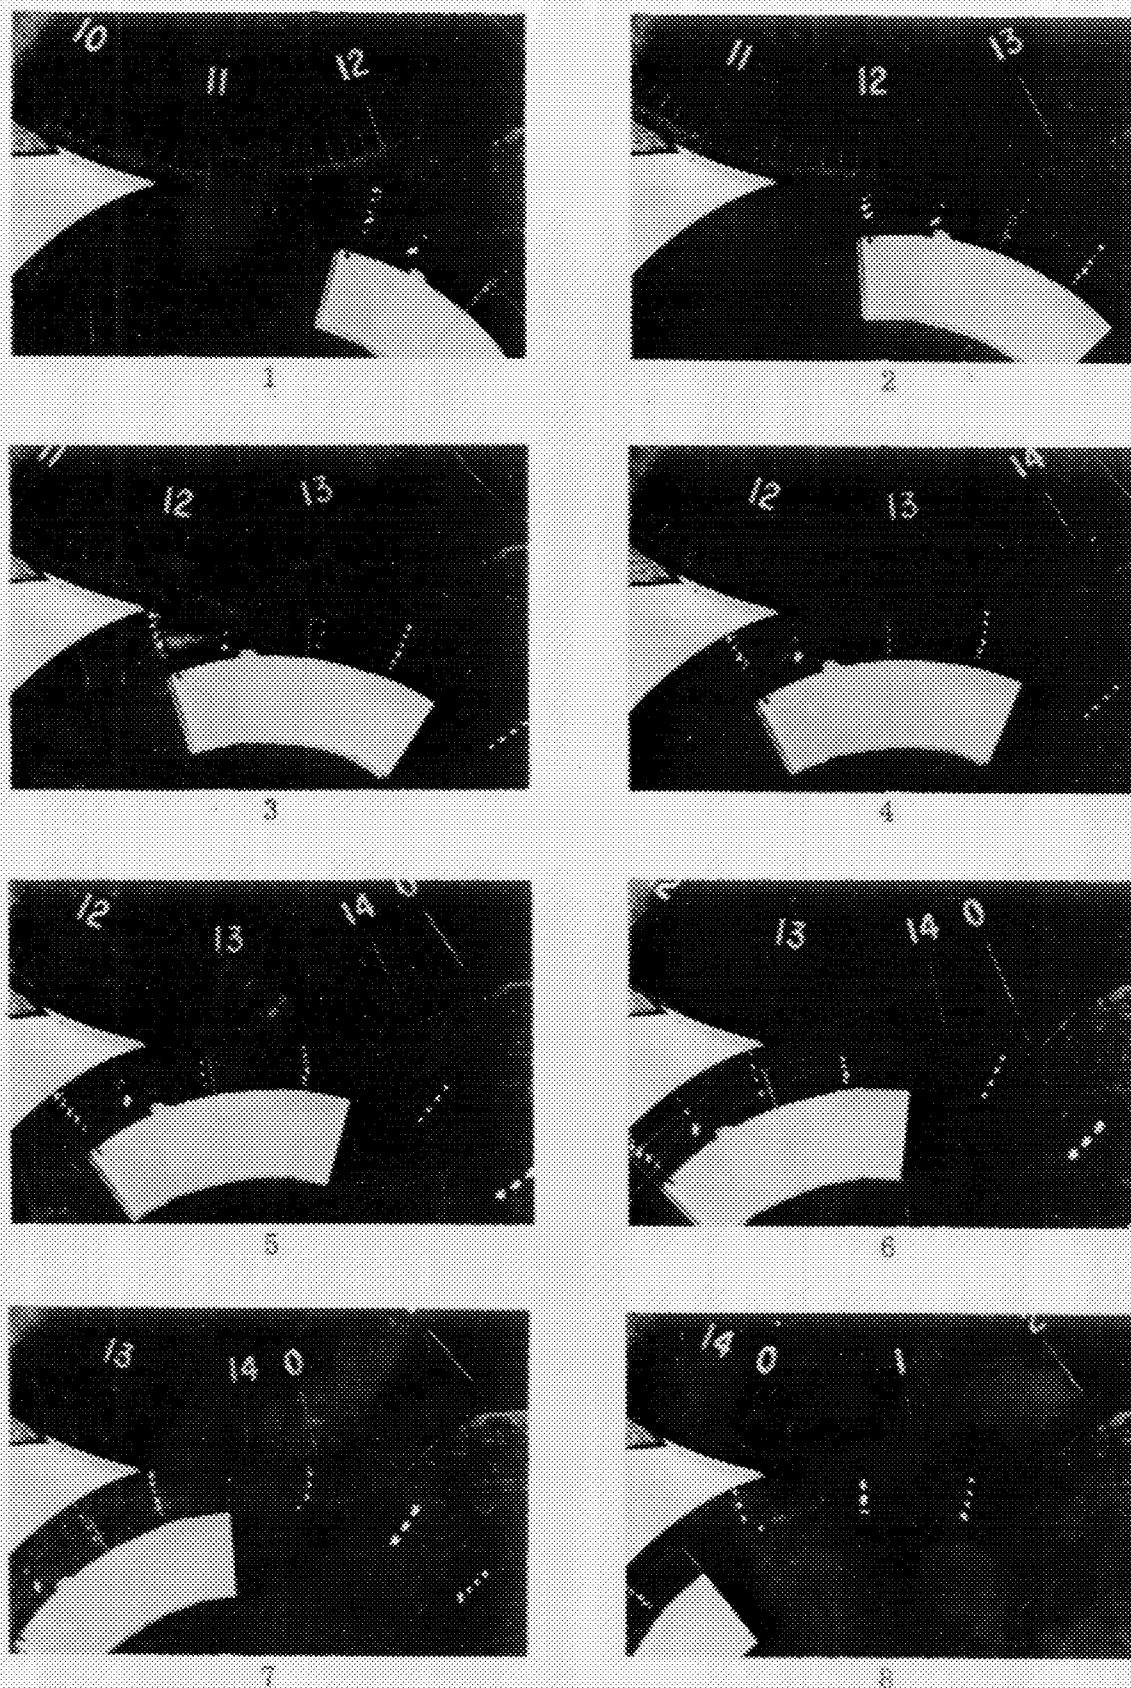
Fig. 2 — Rolling rubber tire

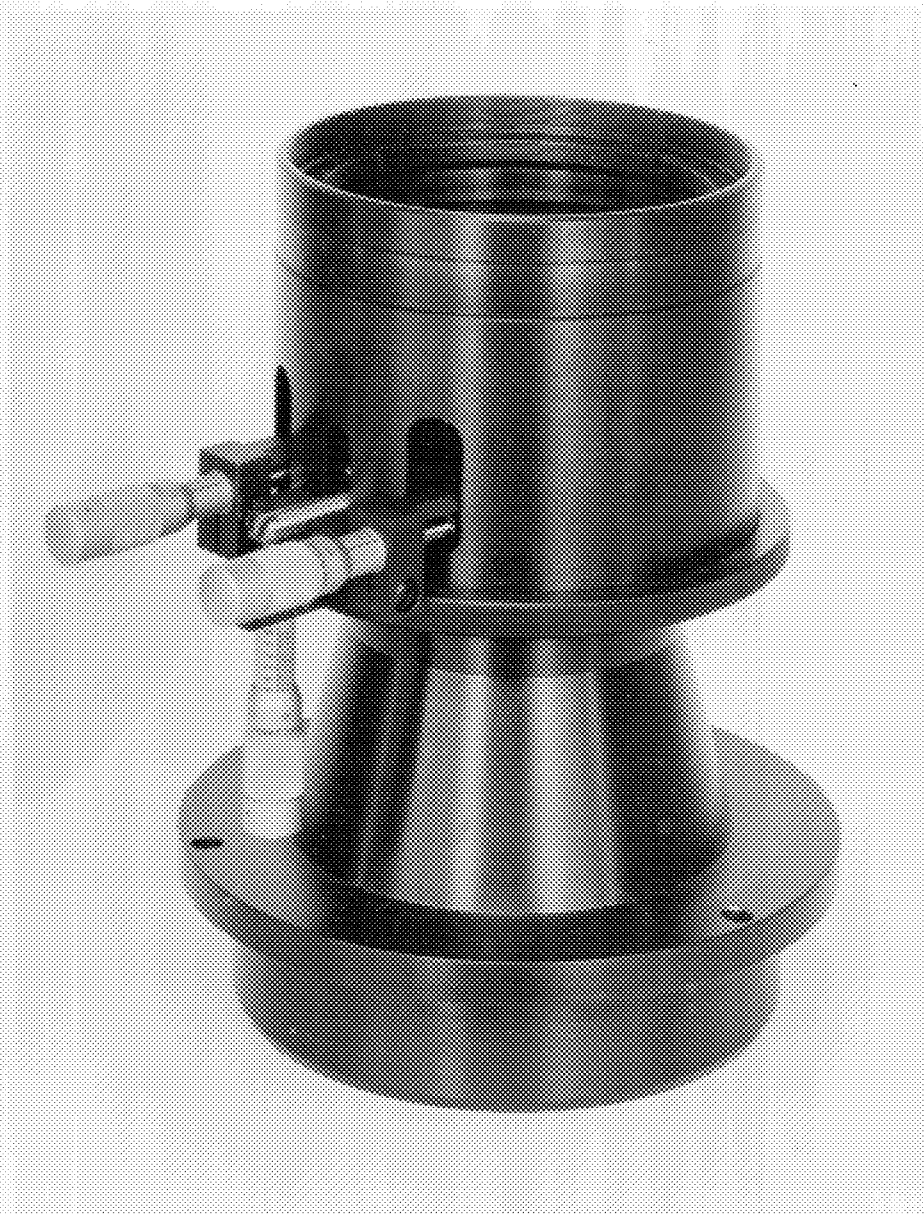
Figure 3

New Relay Lens Cell with Fine Adjustment
Micrometers

Zero Order Stop: The new relay lens cell with the improved zero order stop is fabricated and assembled. Photographs of the assembly are shown in Figs. 3 and 4. Most interior surfaces are yet to be painted with special optical flat black enamel. The stop edges will be glass black to reflect the strong zero order into the light baffle system. The complete lens will then be installed.

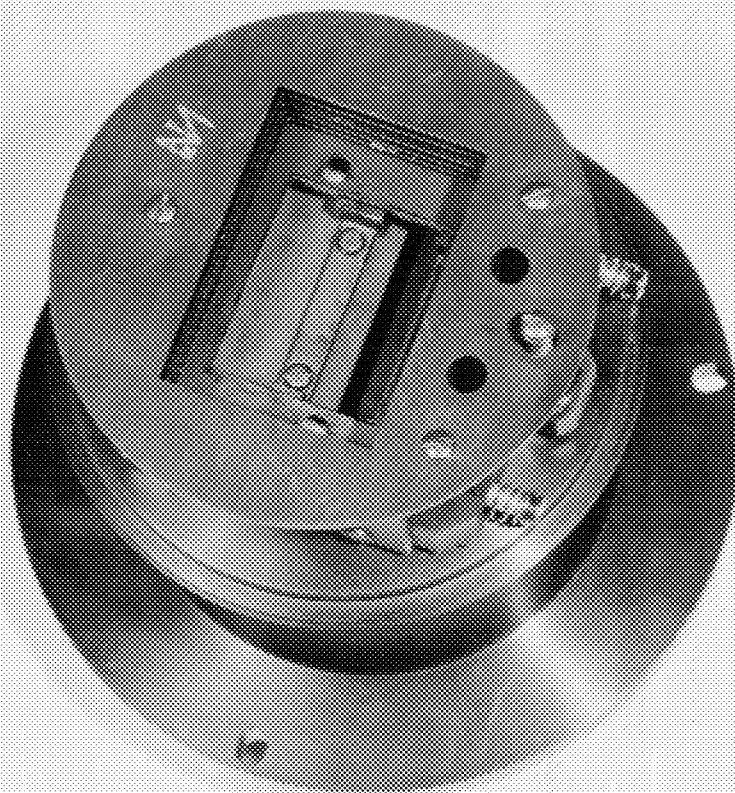
Figure 4

Top View Relay Lens Cell Showing Adjustable
Zero Stop Blades

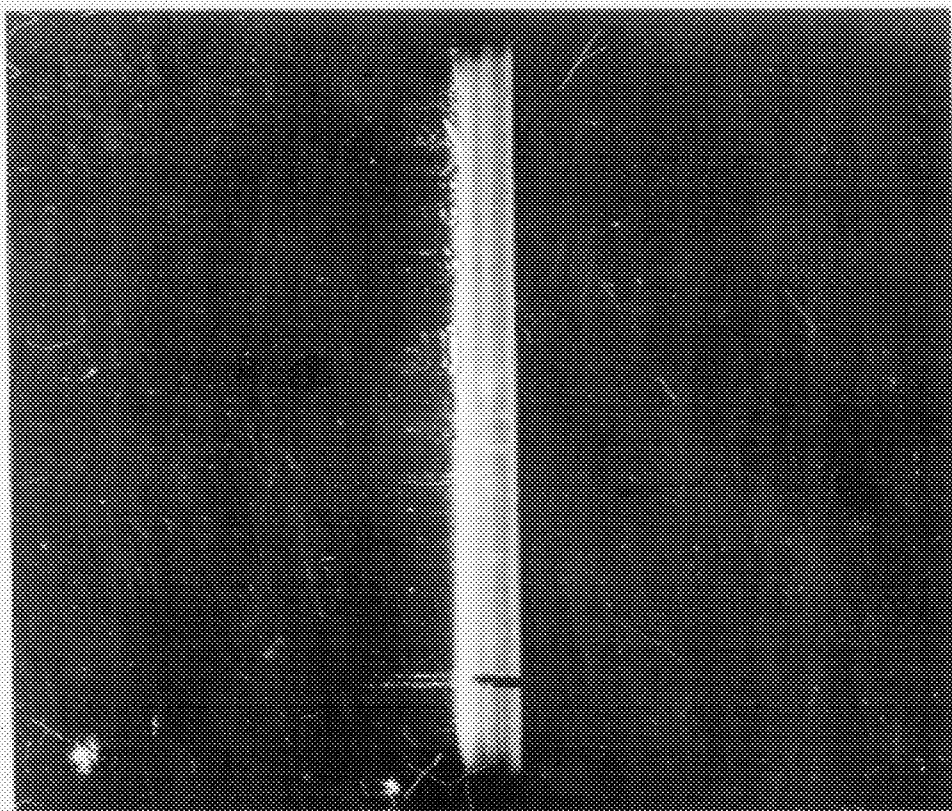
Figure 6

Images of Dot Patterns (2X)

Point Image Tests: In order to determine that flight film correlations are being processed to the maximum capability of the unit, a series of tests were made using dot patterns. These patterns, shown in Fig. 5, are approximately .001 inches wide and are enlarged 2X. The exposures were made statically using the 4 x 5 camera in the processor with Polaroid 200 film. The resultant images were measured as .0025 inches wide in the range direction and are shown in Fig. 6.

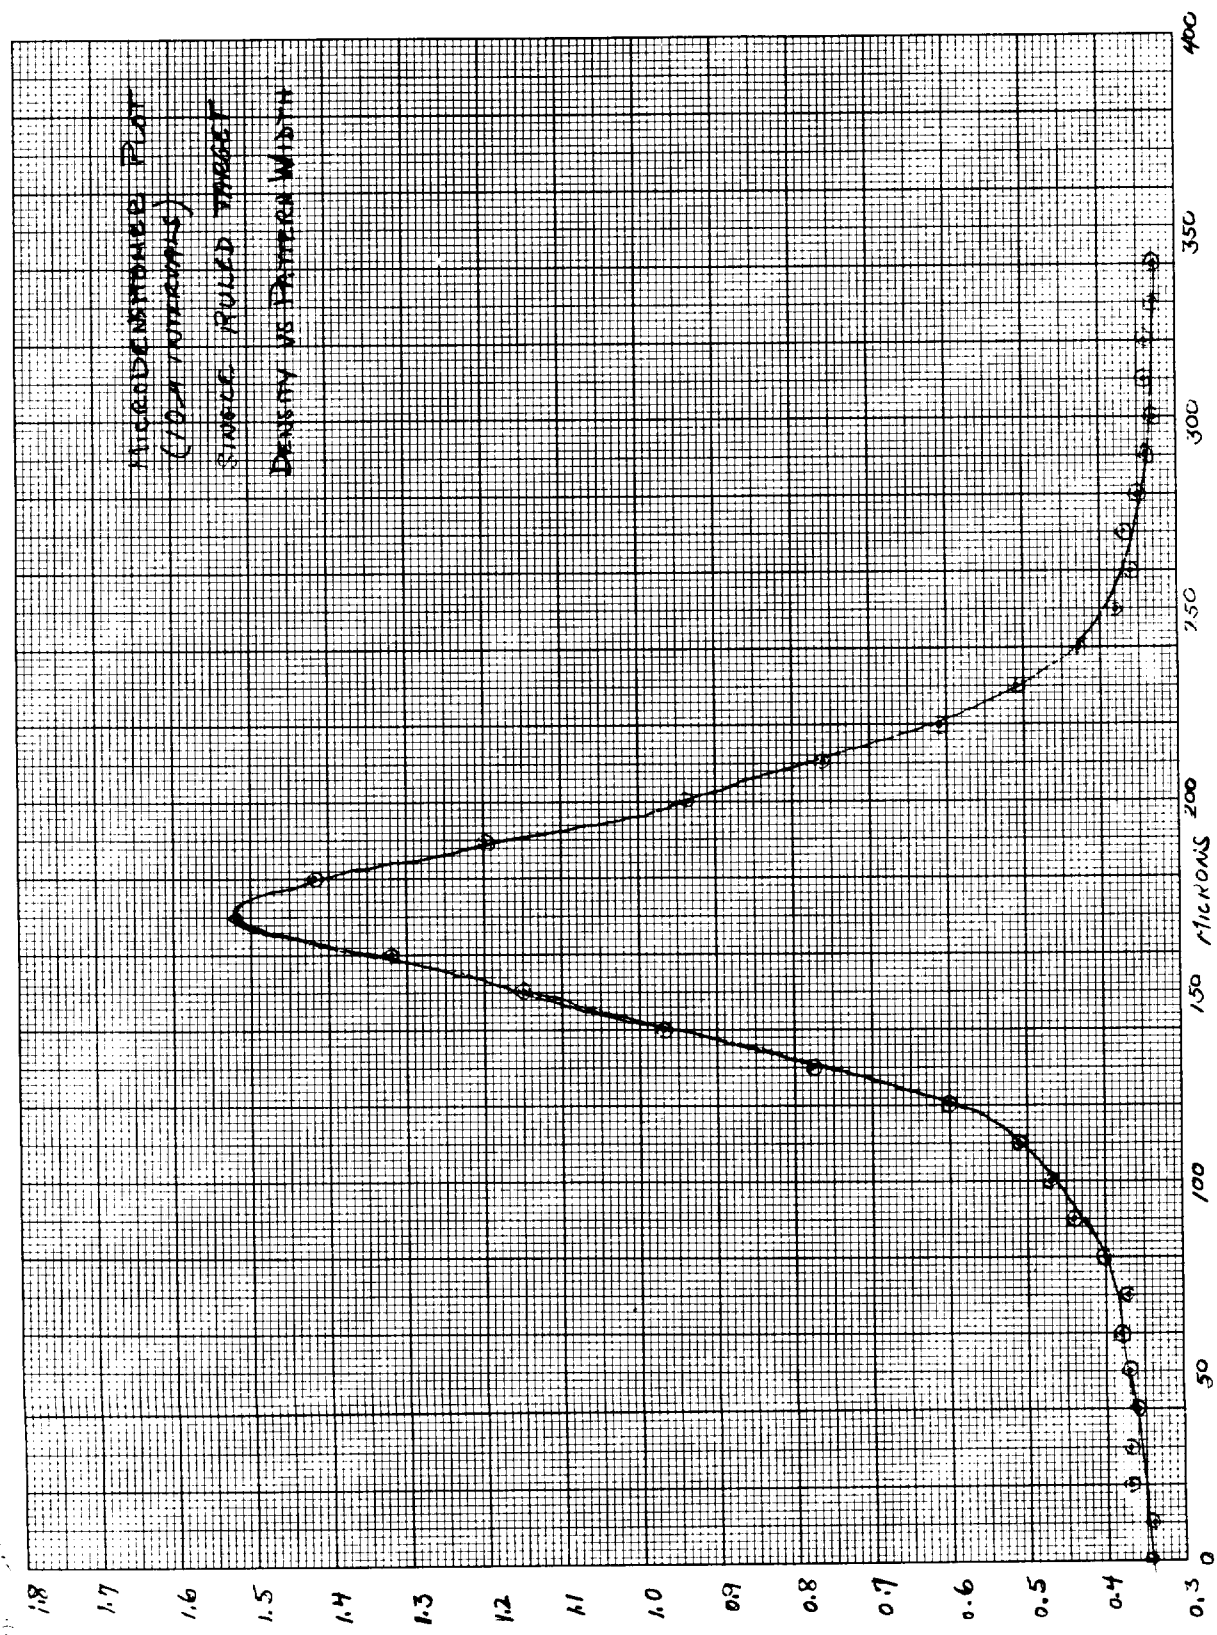
Fig. 1 Microdensitometer trace, single ruled target
